Restoration of a Mountain Tunnel Damaged in the 2016 Kumamoto Earthquake

Shigeru FUKUHARA ▶ Director Engineering Second Division Kumamoto Reconstruction Project Office Kyushu Regional Bureau Ministry of Land, Infrastructure, Transport and Tourism

Kazuhiko NAKAHARA ▶ Construction Manager Civil Engineering Construction Department Kyushu Branch Kajima Corporation

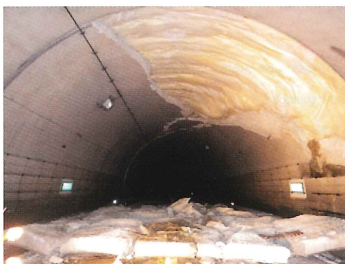
The tunnel was wholly observed and cracks and openings at the joints between the spans of permanent lining were found over the concrete. At several locations, lining concrete had collapsed (Photo 1), and there were cracks and heaving under compressive forces (Photo 2), openings of cracks under shearing force (Photo 3) as well as transversal slippages at the joints, spalling of concrete etc.

Photo 1 Collapse of lining concrete

- 1) Removal of the existing lining and replacement of new lining (approx. 160 m)
- 2) Countermeasure for spalling (injection into cracks, rehabilitation of section walls, carbon fiber sheet attachment, spalling prevention net, application of steel

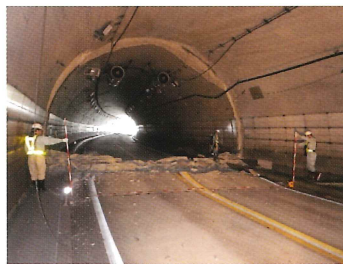
Photo 2 Compressive destruction and earth heaving

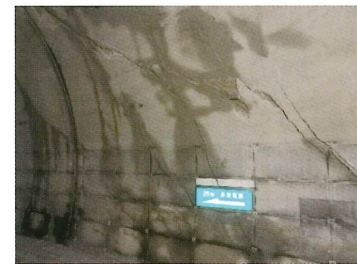
Photo 3 Openings and cracks caused by shearing force

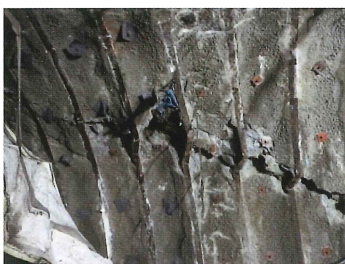
For the sections in category 1), after the removal of permanent lining, steel arched support, shotcrete, rockbolt, etc. were visually checked. Buckling deformation was confirmed for a length of about 20 meters (Photo 4). For this section, all existing steel supports, etc., were removed to install new supports (Photo 5). In other sections, steel arched supports were kept as they were, cracked shotcrete was taken away to cast additional shotcrete and rockbolts. For replacement of lining concrete, reinforcement bars were assembled at the site, and then lining concrete, with high fluidity, mixed with plastic fibers was cast.

Photo 4 Buckling of steel supports

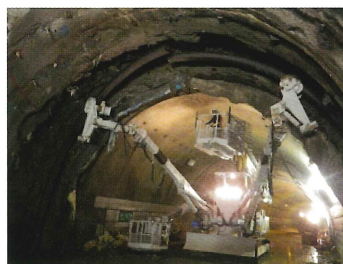
Photo 5 Reconstruction of a collapsed area

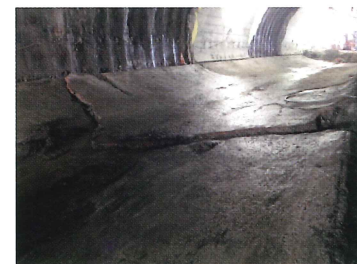
Photo 6 Differences in grade of invert concrete

Of the section of category 1), about 100 meters where the inverted arch concrete had been installed was visually checked for the status of concrete. Along the 60 meter length, at places where there were differences (Photo 6), resulting from destruction of inverted concrete under axial pressure, old inverted arch concretes were removed and new ones were cast. For a stretch of 30 meters with cracks 5 mm or more, non-shrinking mortar was injected.
