# Restoration after the Kumamoto Earthquake

— Tateno Tunnel of JR Hoho Main Line —

This paper reports the damage to the tunnel by the earthquake, presumed cause of the damage and the restoration method adopted.

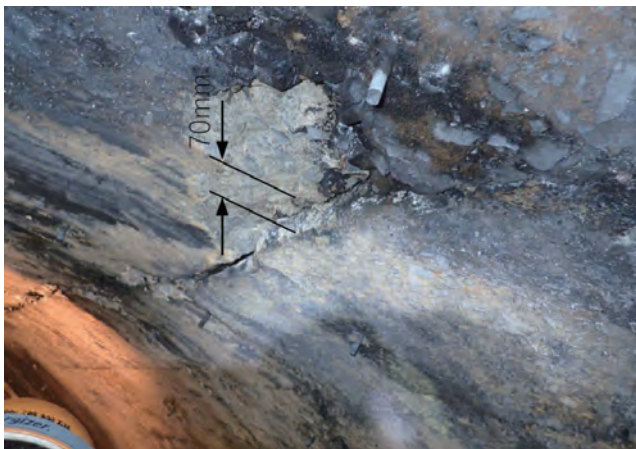
Cracks and spalling of the tunnel lining occurred due to seismic shaking. In particular, the lining was squeezed by approximately 70 mm to the inner side near the center of the tunnel (Photo-1).

Photo 1 Portal deformed conditions

Based on the results of boring survey, it was presumed that the damage was locally increased due to the different responses to seismic motion. This happened because the stratum boundary between andesite and tuff breccia, which have different relative strengths, were located in the damaged section. Restoration was performed with internal reinforcement but since the margin of the building limit was small, T3 panel method, in which steel supports and high-strength thin panels cover the inner lining, was adopted. (Photo-3). The thin panels, made of high-toughness cement board with aramid fibers structured in two directions attached, have a load capacity of 8 kN/m<sup>2</sup> and the minimum construction thickness can be reduced to about 3 cm.

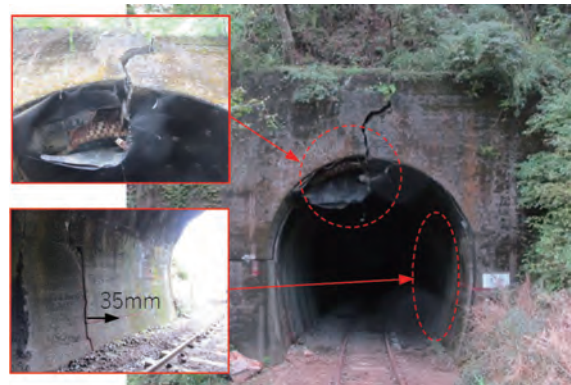
The crown of the portal was ruptured by a vertical crack with an opening width of a few dozen millimeters, and bricks fell from the crown of the lining at the boundary. In addition, the sidewall of the lining, about 5 m from the portal, was squeezed 35 mm to the inner side of the tunnel (Photo-2).

Photo 2 Lining deformed conditions

It was presumed that the ground displacement due to seismic motion was particularly large because the portal was located at the tip of a narrow ridge-like topography and the ground was relatively soft with a small overburden. The broken sections of the portal were repaired with reinforcing plates and rock bolts. The tunnel was integrated with the ground using grouting type forepiling (AGF method) and a 50-cm-thick face wall was constructed in front of the portal (Photo-4).
