Excavation of a Large-Section, Deep Shaft Using a Diaphragm Wall and Chemical Grouting

— Chuo Shinkansen Meijo Emergency Exit —

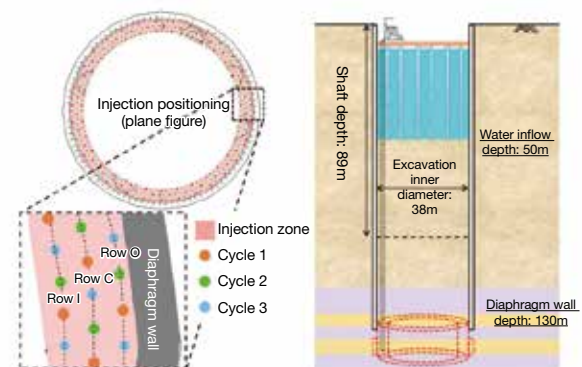
Fig. 2 Chemical grouting schematic diagram

When the excavation proceeded to approximately 50m, water inflow occurred around the observation well, which had already been blocked. In order to estimate the cause of the water inflow, an acoustic tomography survey was conducted. As a result, it was found that the unevenness and inclination of the stratum were larger than expected, which led to the disagreement of the watertight packing of the well closure. It ended in forming the water path.

As a result of acoustic tomography, it was decided to construct a cutoff wall inside the diaphragm wall by chemical grouting, because the water path was considered to exist just below the diaphragm wall due to the unevenness of the stratum. (Fig. 2)

In particular, in (2), the injection pressure of all the holes located in the middle of the three rows was checked (ref. Row C in Fig. 2), and check injections were carried out in the steps where no pressure increase was observed. The check injections were able to compensate for the lack of improvement, and the upward trend of pressure was confirmed in all of the injection areas.

The purpose of chemical grouting is not to “reduce” the water inflow into the shaft, but to “stop” it. The volume per step was increased compared to that of normal chemical grouting because of the large depth and high artesian water pressure. In addition, thorough construction management was carried out by “(1) drilling of the injection hole by two-stage excavation and confirmation of the drilling position by gyroscopic survey” to accurately inject the chemical solution into the deep area and “(2) confirming the injection effect via check injections to maximize the effectiveness of the chemical grouting”.

As a result of the pumping test, the amount of pumping required for drawdown was 1.2 L/min on average, which was very small, and it was considered that a good quality cutoff wall could be constructed by chemical grouting.

After the excavation was resumed, the excavation was completed to approximately 89m without any water inflow.
