Construction of a shaft and a water-tight pressure tunnel with a large cross-section in a lake

- Project for construction of a new spillway at the Kano River Dam Tunnel

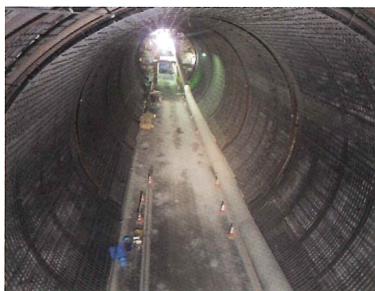
Photo 2 Completion of the reinforcement

As reinforcement material, we introduced prefabricated mesh reinforcement in units, which are designed for lower risk of damage and for saving labor (Photo 2.)
