# Renewal of the lining of mountain tunnels in service

## Construction method to renew a section of the lining concrete

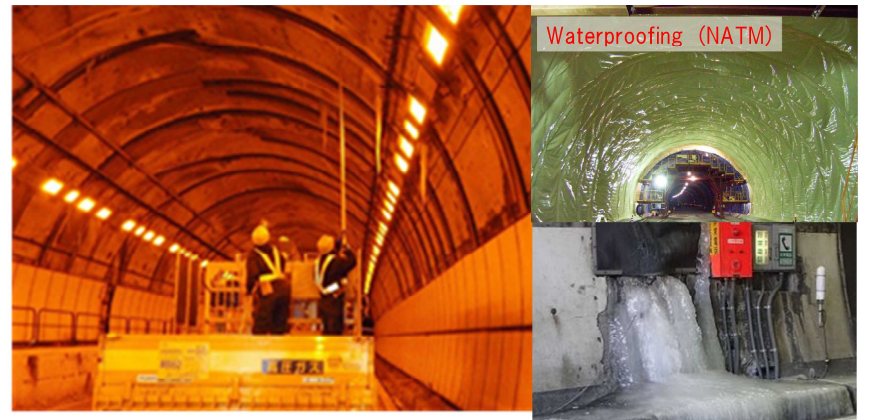
The aging tunnel lining has many cracks and water leaks. The leaking water may freeze into icicles that may hit passing vehicles.

Water Leakage and freezing (icicles)

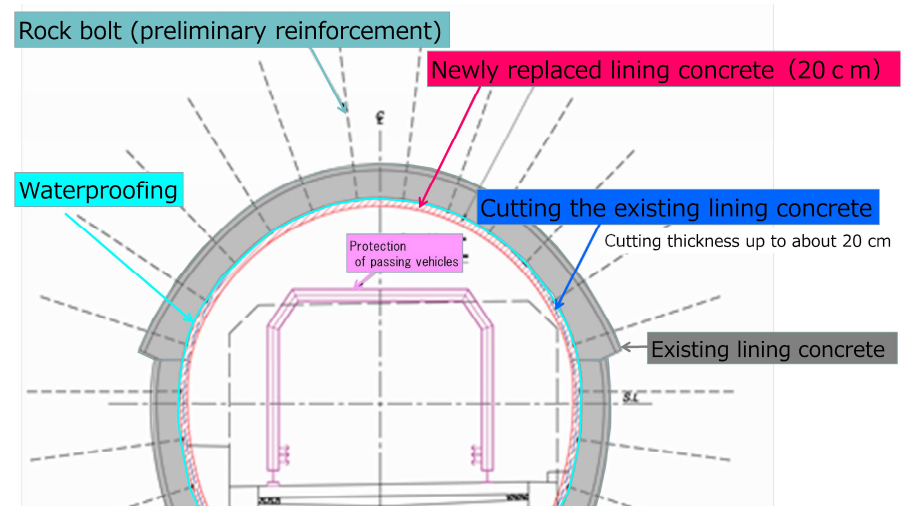
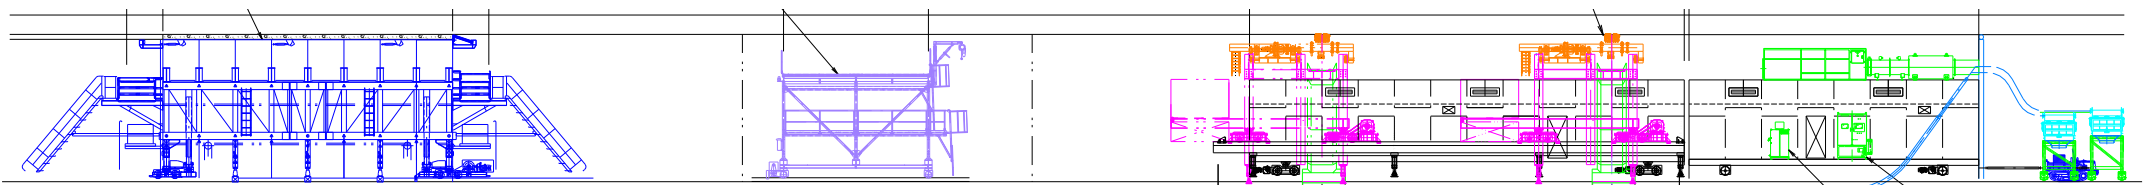
Fig Construction system (appearance diagram)

The new construction method renewing a section of the concrete lining with the expressway still in service will solve the issues

Construction direction →

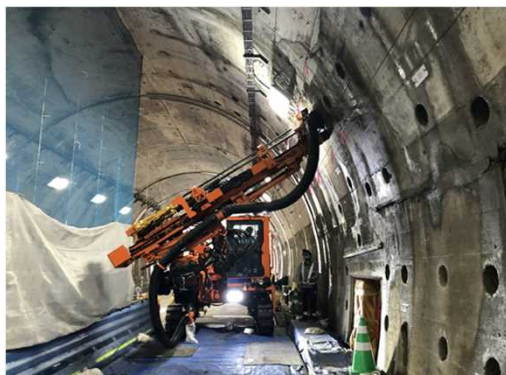
### STEP1

Installation of rock bolts

Reinforce the tunnel with rock bolts before cutting the existing lining concrete.

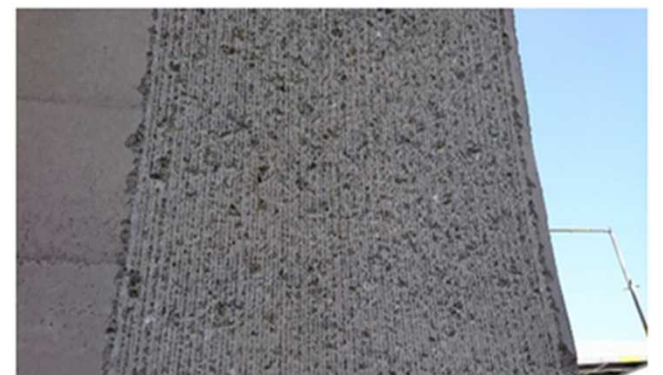
### STEP2

Cutting existing lining concrete

Cutting lining concrete

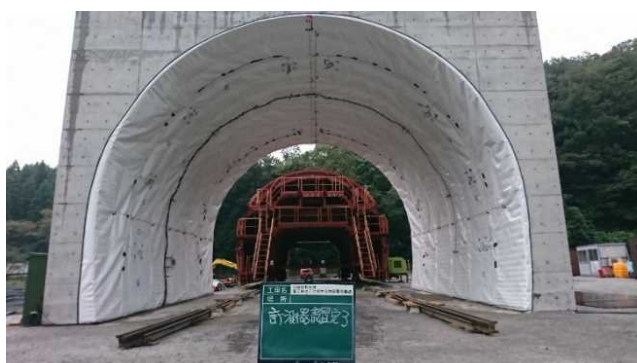
### STEP3

waterproofing

Installation of waterproofing

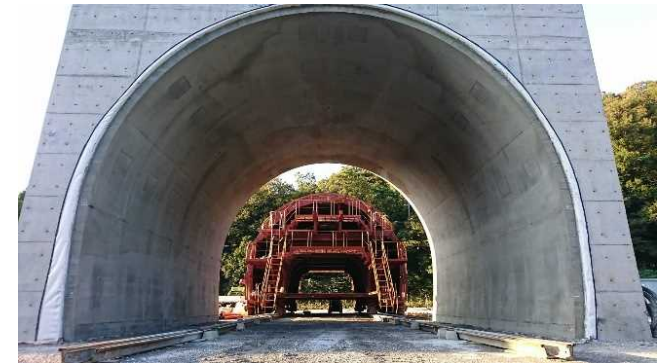
### STEP4

Place new lining concrete

Lining concrete placement
