Mountain Tunnel Construction in Fragile Ground in Volcanic Regions

— National Highway 57th Takimurozaka Road, East Takimurozaka Tunnel Construction (Phase I) —

Hirohito TABATA ▶ TAISEI CORPORATION

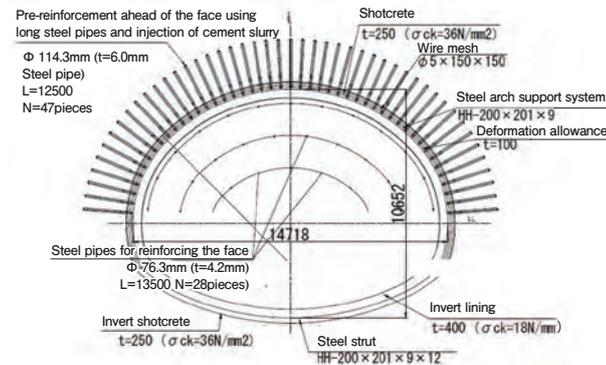
Fig. 1 Support structure in fragile geological section

This tunnel is a large-section tunnel with a flat shape and an excavated cross-sectional area of more than 100 m², as shown in Fig. 1. In the fragile geological section, cracks appeared in the shotcrete, the main support member, and a crown settlement, which exceeded the control value of 45 mm, was measured inside the tunnel. In this section, a sand and gravel layer were distributed in the lower half of the section, as shown in Fig. 2. The uniaxial compressive strength of this layer was less than 0.2 MPa, and softening due to ground water was also evident.

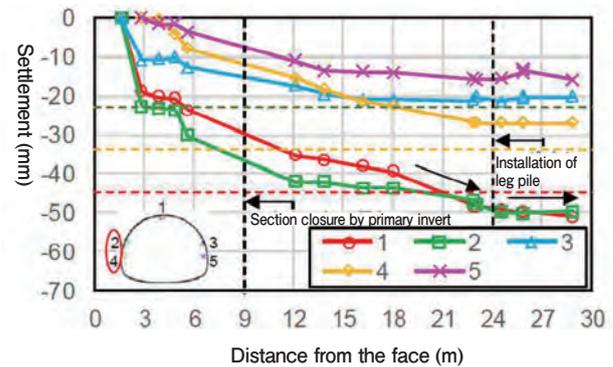
Fig. 3 Settlement measured in fragile section

Fig. 3 shows the settlement displacement measured at a cross section located in the section where the deformation occurred and 459 m away from the portal. A significant settlement due to excavation was observed in the 12 m to 23 m section away from the face after the primary invert completion and before the leg piles described below were installed, especially in the crown, left shoulder and left leg areas.

The need for leg piles was judged based on the displacement speed trend after the primary invert completion and whether the amount of settlement exceeded the control value of 34 mm before displacement converges. As can be seen from Fig. 3, after the leg pile installation, the displacement generally showed a trend of convergence, especially at the points 24 m or farther away from the face, confirming the effectiveness of this countermeasure work.

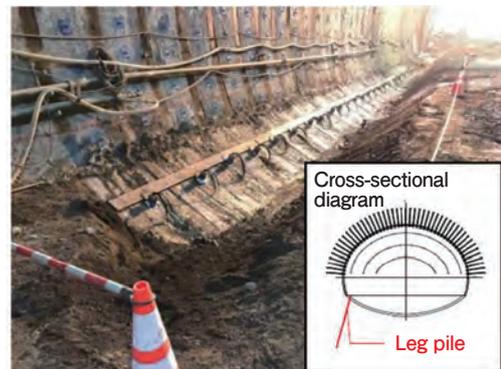
Fig. 4 Construction of leg piles

Even after primary invert completion as a countermeasure against settlement, displacement continued to increase with the progress of excavation. Based on geological investigations, geological observations and displacement trends, it was concluded that the ground bearing capacity was insufficient, particularly on the left side. To prevent settlement, leg reinforcing piles shown in Fig. 4 were constructed on the left side leg areas with an extension of 86 m.
