# Breakthrough with Using of Various Countermeasure Works in Landslide Topography and Cliff Cone Deposit Sections

The Kuji Osanai Tunnel Project, in Kuji City on the northern coast of Iwate Prefecture, is the construction of a 1445.3 meter-long road tunnel with the cross-sectional area of 109 to 128 m<sup>2</sup>. This paper describes the countermeasures for the tunnel's small overburden section with landslide topography, the boundary fault section in fracture zone, and the talus cone sediment at the tunnel portal.

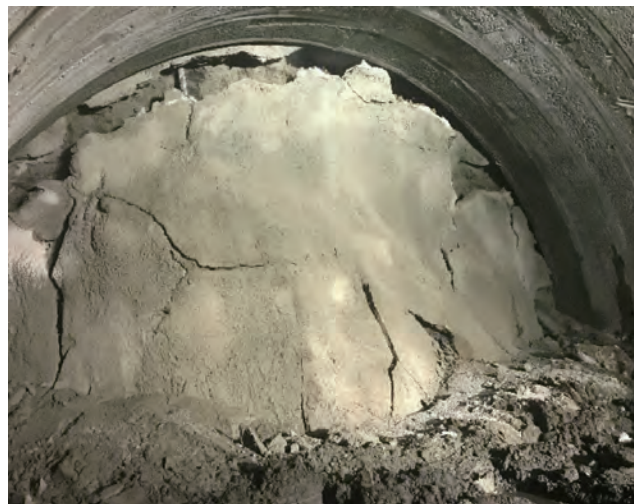
Through void investigation, interbedded clay soils with reduced ground strength were identified. Thus, following measures were taken for the crown, face and support reinforcement.

Photo 2 Ground squeeze

- long steel pipe forepiling and long facebolt
- primary invert with invert strut

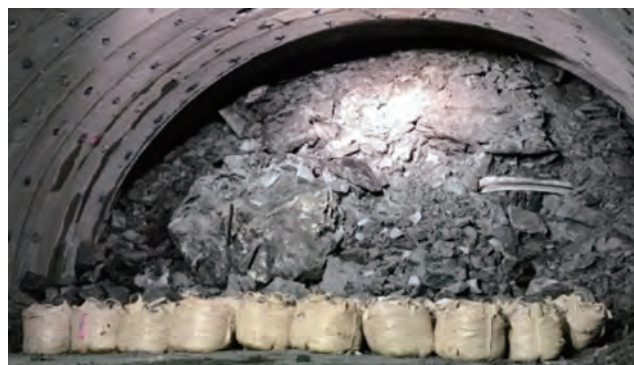
The boundary fault was located near the center of the tunnel length. A localized collapse occurred in front of the assumed point. Excavation was continued on the assumption that it was a branch fault rather than the main fault, but a large-scale collapse occurred at a point 2 meters further down the tunnel.

Photo 3 Large collapse

Based on the scale of the collapse, a boundary fault was assumed, and a borehole camera was used above and in front for void investigation to confirm the area affected by collapse.

Following shear reinforcement and support reinforcement measures were taken to prevent the expansion of a large loosening area and plastic area.

- long steel pipe forepiling and long facebolt
- temporary upper half inverts and additional rock bolts
- primary invert with invert strut
