# Tunnel Construction through Ground with Landslide Potential Adjacent to the Median Tectonic Line with Various Countermeasures from Inside and Outside the Tunnel

—Matsuyama Expressway Myojinsan Tunnel Phase II—

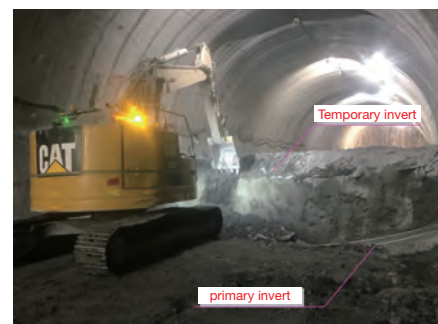
The ground with landslide potential around the tunnel is composed of alternate layers of sandstone and shale. Folds and strong weathering were observed, and therefore, it was necessary to take measures to stabilize the cutting face so that they could cope with rapid changes in the ground. Because of the close proximity of the construction site to the in-service line, it was also necessary to take measures to control displacement as well. Therefore, we adopted long steel forepoling pipes ( $L = 12.5$  m,  $180^\circ$ ,  $\phi 114.5$  mm) and long face bolts ( $L = 13.5$  m) as measures to stabilize the face, and constructed an upper half temporary invert as a displacement control measure as shown in Photo 1.

Photo 1 The temporary invert
