# Tunneling in the Fragile Ground with Low Competence Factor Affected by Faults

— Nakaoyama Tunnel —

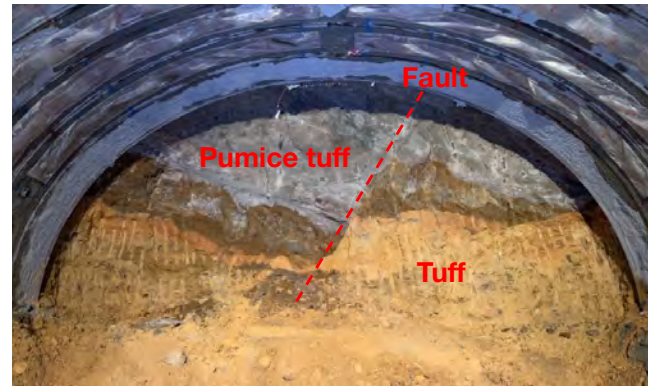
Tunneling work was advanced while checking the ground conditions by conducting survey boring ahead of the face. However, due to a change in the geological features from around 250m point of the tunnel, pumice tuff and tuff accompanied by a fault, which is not assumed in the preliminary geological survey, appeared on the tunnel cross section (Photo 1).

Photo 1 Occurrence of fault

As the displacement increased with the presence of these strata, breakage of rock bolts and cracks on the shotcrete became prominent. While the displacement proceeded even after the face separation exceeded 3D (D: tunnel diameter), the final displacement amount in the horizontal direction was over 180 mm.
