# Maintenance of the Railway Tunnel Built on Serpentine

*Yusuke NAKANISHI* ▶ Deputy section chief, Construction department, Hokkaido Railway Company

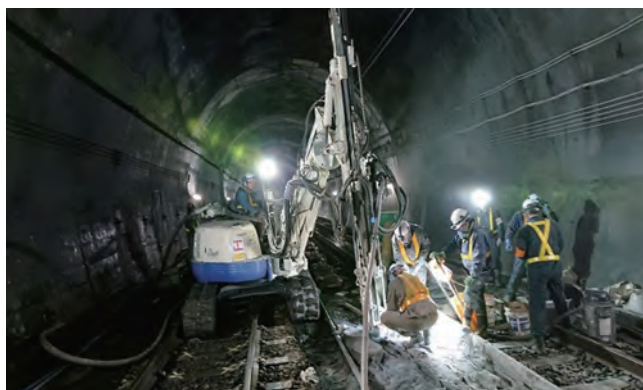
Photo 1 Self-drilled rock bolt placing

The 4,523 m long double-track electrified section railway mountain tunnel, which is currently in service, was put into service on 1 October 1969, one year later than planned, due to numerous deformations such as support works being pushed out toward the inner space due to the squeezing of the ground since the initial excavation. No significant deformations were observed during the first 18 years of service, but around 1987 the roadbed began to rise and the inner space to shrink in the horizontal direction, similar to that observed when the main tunnel was excavated. In 1996, measures were implemented at night when train operations ceased, since, from the start of measurements, the uplift of the roadbed in some sections was as large as 370 mm, and the inner space was also reduced by 73 mm below the sidewalls which were too large to ignore. Reinforcement work included ground anchors in the sidewalls as a countermeasure against the shrinkage of the inner space, and reconstruction of the joint between the invert and the sidewalls and of rock bolts in the roadbed (Fig. 1) to prevent the uplift of the roadbed, as the joint between the invert and the lower parts of the sidewalls had 'gaps' in its structure and could not transmit axial force. As a result, the deformation was controlled. After these measures, the gradual roadbed uplift and inner space reduction continued in other parts of the tunnel, and it was anticipated that if this deformation continued, more maintenance work would be required to keep the trains running safely. It was therefore decided to start countermeasure works again in 2010. The basic policy for the reinforcement work was, as the measures taken in 1996 were sufficiently effective, to use rock bolts to control the deformation in the same way. In addition, as 'gaps' were found at the joint between the invert and the lower parts of the sidewalls, the joint was reconstructed. Specifically, R32 self-drilled rock bolts ( $n=36$ ) with a length of 9 m were driven in the center of the roadbed section in a downward direction, and R32 self-drilled rock bolts ( $n=33$ ) with a length

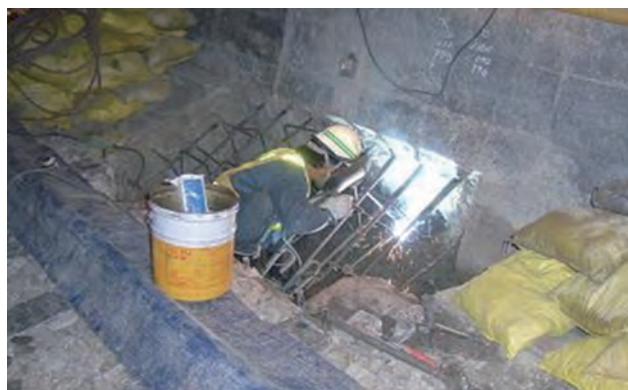
Photo 2 No-shrink mortar placing

of 8 m were driven in the direction horizontal to the inbound line (Photo 1). To reconstruct the joint between the invert and the lower parts of the sidewalls, part of the lower parts of the sidewalls was demolished, reinforcing steel steel bars were jointed to the rebars of the invert and inserted into the sidewalls and fixed using chemical anchors, after which no-shrink mortar was cast (Photo 2).
