## Initiatives of Inspection Technology (Non-distractive methods)

## Operation & Maintenance of Inter-city Expressway Network

### Renewal and Major Rehabilitation Projects

## Restoration project of damaged tunnel

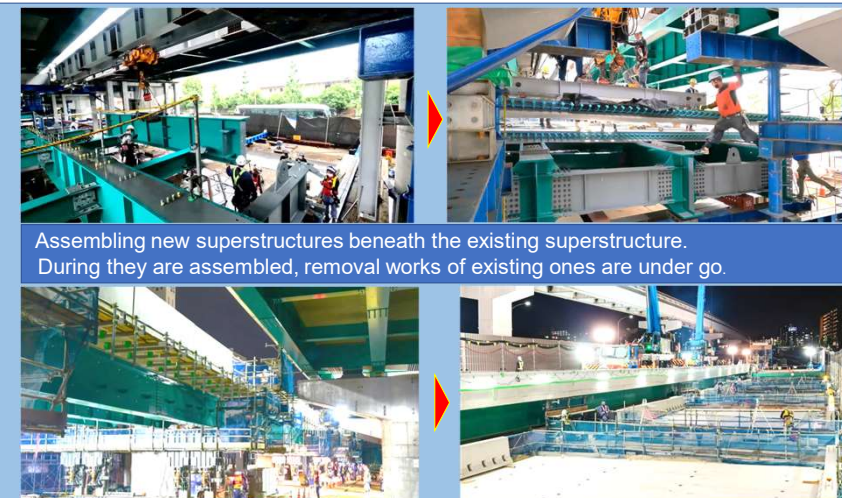
**Superstructure replacement :**  
Casting in place hollow slab deck → Simple steel girder + Precast concrete slab

**Chugoku Expressway**  
Residential area  
Osaka Monorail  
Residential area  
Prefectural Road 2  
Osaka Chujo Belt way

The environmental condition of the projects. Conventional crane method seems inefficient in works schedule.

After removal of superstructures, by jacking up assembled superstructures in one batch and connecting them simultaneously, the major part of replacement works will be proceeded efficiently.

### "Superstructure batch replacement with jack-up"
