Renewal of the lining of mountain tunnels in service (New method !)

Construction method to renew a section of the lining concrete

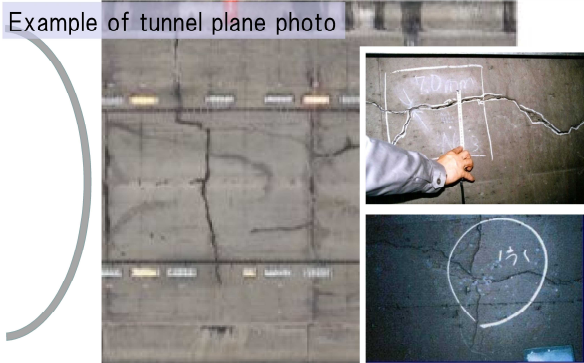
Example of tunnel plane photo

Cracks of lining concrete

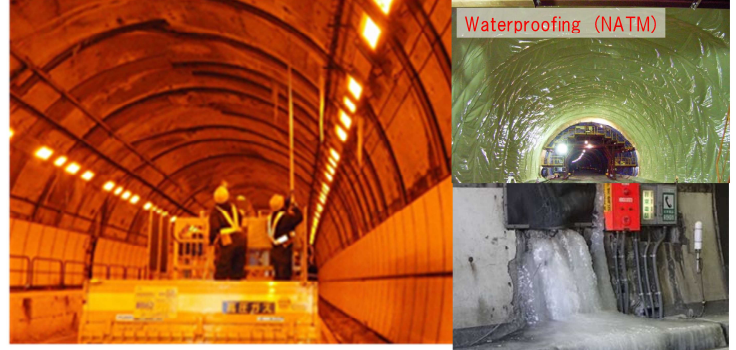
Water Leakage and freezing (icicles)

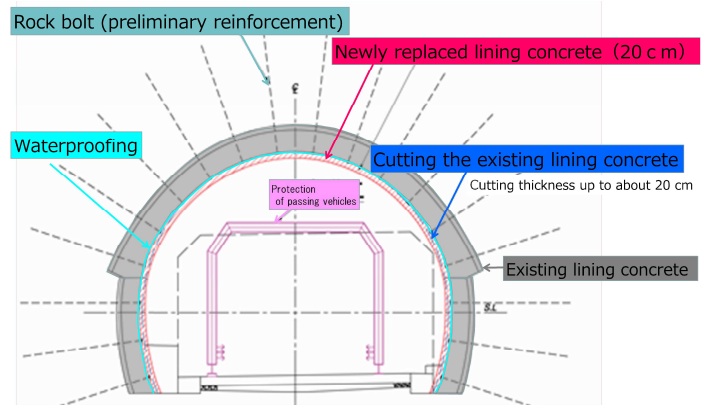
The new construction method renewing a section of the concrete lining with the expressway still in service will solve the issues.

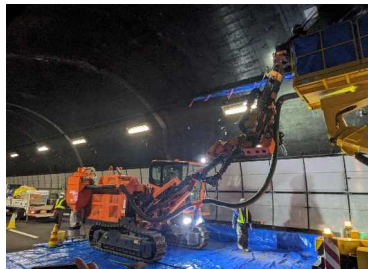
STEP1

Installation of rock bolts

Reinforce the tunnel with rock bolts before cutting the existing lining concrete.

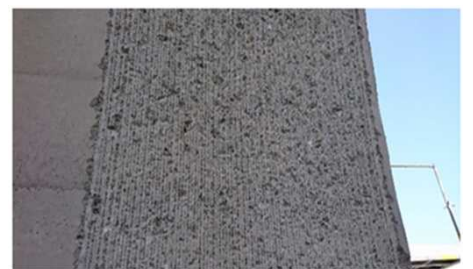
STEP2

Cutting existing lining concrete

Cutting lining concrete

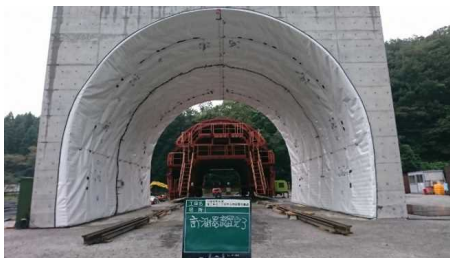
STEP3

waterproofing

Installation of waterproofing

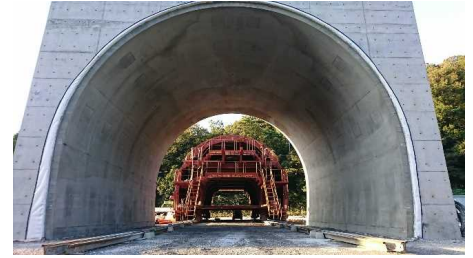
STEP4

Place new lining concrete

Lining concrete placement
