Neighboring Construction of a Long and Massive Mountain Tunnel's Fault Crush Zone

— The Shin-Hokuriku Tunnel of the Hokuriku Shinkansen —

Ryo KASHIWAGI ▶ Tsuruga Construction Site Office, Osaka Regional Bureau,
Japan Railway Construction, Transport and Technology Agency (JRJT)

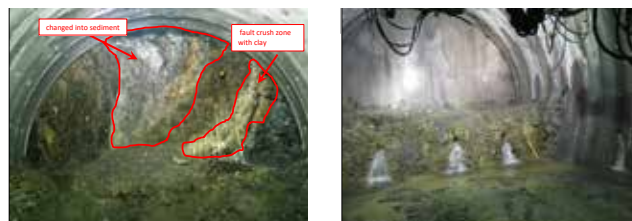
Fig. 2 Condition of the Fault Crush Zone during Excavation

When excavating a fault crush zone directly below an existing highway tunnel for about 40 meters, crushed clay and a high amount of high-pressure water flow into tunnel is found (Fig. 2). So increased carefulness and consideration of safety is necessary in order not to disrupt the highway, which is an important trunk road. Finite Element Analysis (FEA) has been conducted beforehand to assess the amount of settlement and pressure on the lining, along with plans to measure and compare during excavation. In addition to using steel forepiling and long steel face bolt are adopted as auxiliary methods, closure using initial invert within three days after start of excavation is planned so early closure will minimize any influence on the existing tunnel (Figs. 3 & 4).
