Overcoming Challenges: Small Overburden, Acidic Water, Construction Under a National Road

— The Yamagata Zao Tunnel, Tohoku Chuo Expressway —

Project overview

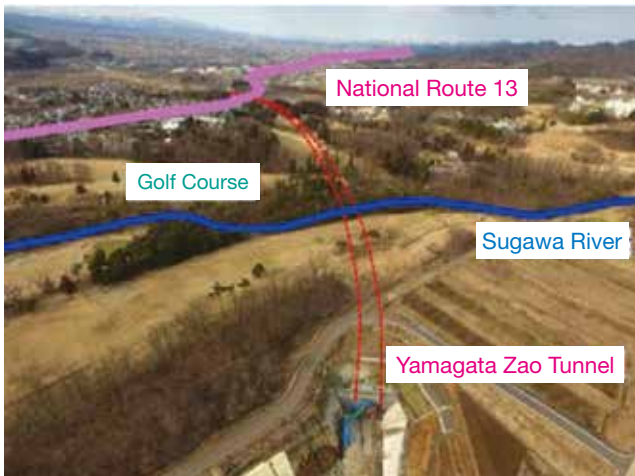
Fig. 1 Conditions surrounding the tunnel

The Tohoku Chuo Expressway is an approximately 270km highway that connects Fukushima and Akita Prefectures. The Yamagata Zao Tunnel is an approximately 944-meter tunnel at the foot of the Yamagata Prefecture side of the Zao mountain range, famous for rime on trees. This tunnel has an overburden of 9.9 ~ 24.5 m and is almost entirely covered by small overburden of 1.5 D (D = 12.4 m) or less. Right above the tunnel cross a golf course, a river and a national road and near them are amusement parks and houses, so the impact of the tunnel excavation on those structures were concerned. The soil, composed of Quaternary mudflow sediments and Neogene tuff and tuff breccia, is, overall, less solidified and soft. Therefore, as the excavation system, the mechanical excavation was adopted, and as the main excavation method and auxiliary method, the full-face early closure and the injection type long steel pipe forepiling (AGF) were selected. The construction started in March 2016, and the tunnel was completed safely about one and a half years later, in September 2017.
