Verification of Deformation During Excavation of Pelitic Schist and Effect of Countermeasures

— The Matsukaya Tunnel on National Highway Route 197 —

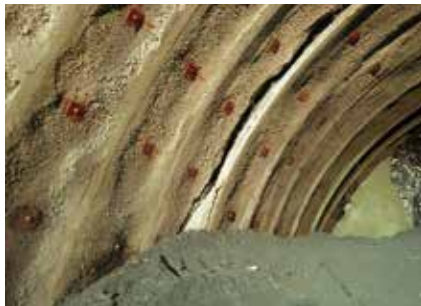
Photo 1 Extrusion of primary support

During the excavation of pelitic schist, damage and extrusion of the primary support occurred frequently (Photo 1). To secure the soundness of the primary support and the necessary inner space, the primary support had to be repeatedly rebuilt. After the excavation, the invert was closed early to control the displacement and stabilize the tunnel. However, the earth pressure increased with time even after the invert was closed, and the steel support buckled (Photo 2). In addition, damage and heaving of the invert concrete were recognized, and tunnel was considered at risk of deformation after the start of service.

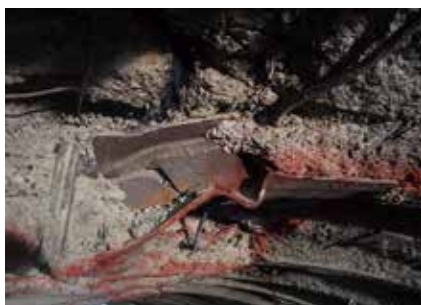
Photo 2 Buckling of steel support

The Matsukaya Tunnel is a two-lane road tunnel with a total length of 1,090 meters. The soil consists mainly of fragile pelitic schist. During the excavation, maximum horizontal displacement of 770 mm in one side occurred, along with significant deformation of the primary support including cracks in shotcrete, fractures of rock bolts and buckling of steel support, in addition to cracks and heaving of invert concrete.
