Large-Section Shield Tunnel Excavated Directly Beneath Runway in Service Tokyo International Airport Tunnel

Seiji JINBO ▶ Construction Manager, Tokyo Civil Engineering Branch, SHIMIZU CORPORATION
Ryunosuke KASHIMA ▶ Design Manager, Civil Engineering Technology Division, SHIMIZU CORPORATION

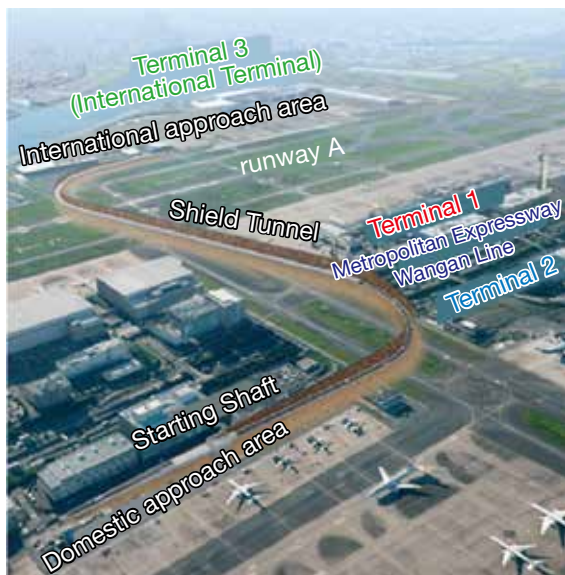
Fig. 1 Bird's eye view (image)

This project involved constructing a road tunnel that can be used by large buses using a shield tunneling method in order to improve the convenience and punctuality of connections between international and domestic flights at Tokyo International Airport. The outer diameter of the shield tunnel was about 12m, and a mud shield was used. The shield tunnel passed directly under airport facilities such as runways, taxiways, aprons, monorails, and highways in service in the heterogeneous and extremely soft ground of the reclaimed land, so one of the most important issues in this project was to minimize the impact on these critical structures. Fig. 1 shows a bird's-eye view of the tunnel.

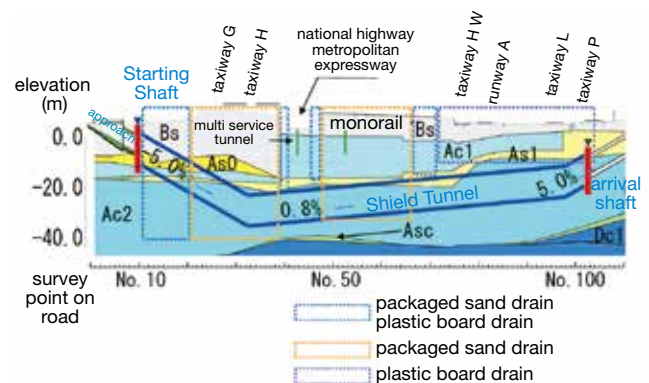
Fig. 2 Longitudinal image

Fig. 2 shows the ground in the construction area and the longitudinal alignment of the tunnel. The ground is very soft, with the upper sand layer (As1 layer) dredged and filled with sludge (Ac1 layer) and construction soil (Bs layer) dredged from the navigation channel in Tokyo Bay. In addition, the excavation cross section has obstructions such as drainage material used during ground improvement and steel pipe piles left over from the construction of the Tokyo International Airport Offshore Development Project. The volume of deformation was measured by level surveying during the night when the airport facilities were closed, and by ground-mounted synthetic aperture radar to determine the deformation trend when the airport was inaccessible. The ground-mounted radar was used to determine subsidence trends because the radar has a small angle of incidence and low reflection intensity, which results in large variations in measurement accuracy. In addition, the excavation data
