# Repairing the Pilot Tunnel of the Seikan Tunnel

## Tappi Pilot Tunnel Repair Works

Tatsuo OKADA ▶ Assistant Director, Maintenance Division Hokkaido Shinkansen Construction Bureau  
Japan Railway Construction, Transport and Technology Agency (JRRT)

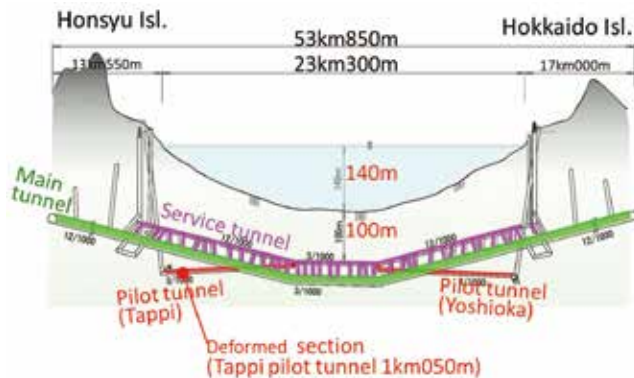
Fig. 1 Outline of the Seikan Tunnel

The Seikan Tunnel is a long undersea tunnel with a total length of 53 km 850 m. The undersea section of 23 km 300 m consists of three tunnels (the main, working, and pilot tunnels). The deepest part of the tunnel is 240 m below the sea surface and is subjected to strong water pressure of up to 2.4 MPa. The tunnel is used under unique conditions as it is constantly exposed to strong water pressure and inexhaustible spring water from the seafloor. (Figure 1) Due to the unique environment of the Seikan Tunnel, various measurements have been carried out continuously since its opening. A wide range of items is measured including the displacement of the inner space of the main, working, and pilot tunnels, the amount, pressure, and quality of water inflow, the neutralization and strength of the concrete, and the deterioration of the injection material. Significant changes were discovered at the pilot tunnel, and these changes had to be controlled through various measures, which is reported in this paper.
