22.5% uphill electric cable tunnel by mud-pressure shield in composite ground containing weathered granite

Masaaki YANO ▶ Kumagai Gumi Co., Ltd.

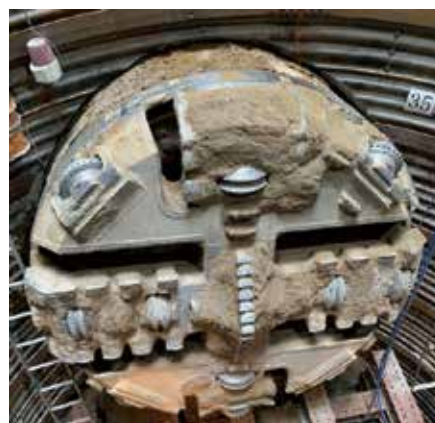
Photo 1 Arrival status

in the pump empennage and interfered with pump rotation. The pumps were able to reach the same speed (average 153 m/month) in the steep section as in the other sections, and the overall process took about 10 months (average 143 m/month) for a distance of 1.5 km, as originally planned (Photo-1).
